**FINAL REPORT  
DIPA BIOTROP 2018**

**Water Quality Assessment for Aquaculture and Chemical Content of  
Mangrove – Based Food**

**YAYASAN INSPIRASI KELUARGA KeSEMaT  
(IKAMaT)**

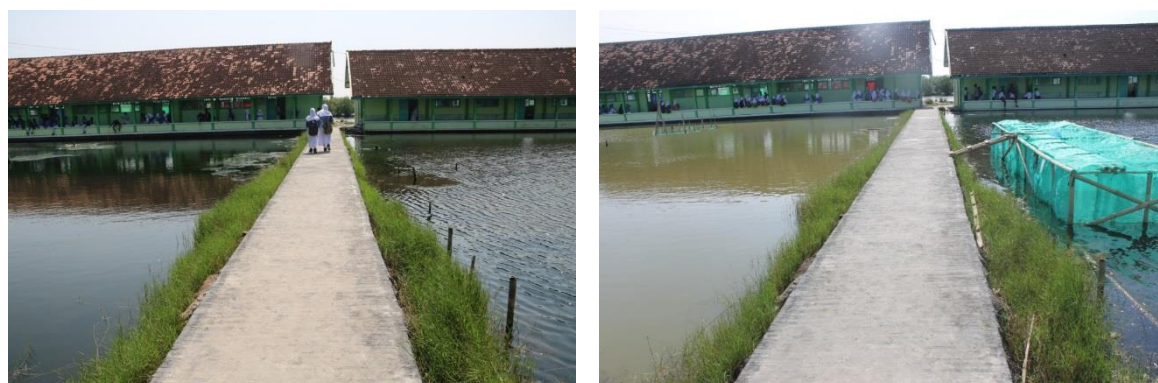
**Picture 2.** Trial pond design

Before there was a pond

In Table 2, attached a list of tools and materials used in making the trial pond. Materials to make a trial pool using easily available materials in the research area at SMPN 3 Satu Atap. This is also to find out the resistance of materials such as bamboo as a framework for making a trial pond. In the trial pond, the feed used in the study is organic food. This is to maintain the condition of the waters and also reduce the intake of chemicals, because when using feed pellets feared will affect the chemical and physical conditions of the research location.

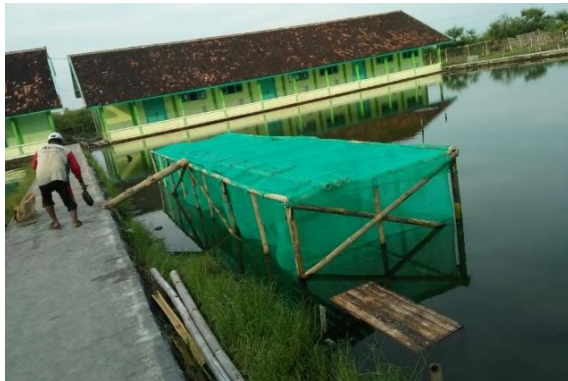
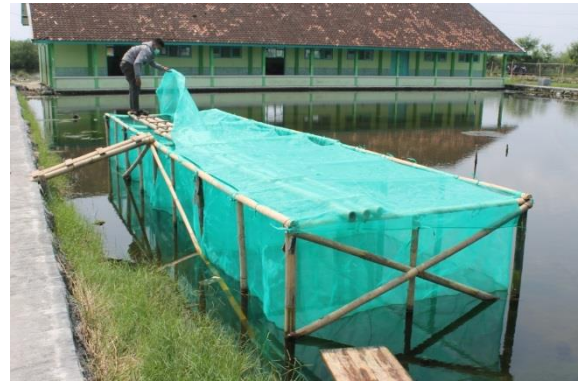
After there was a pond

The process of making a trial pond

The test pond is ready for fish

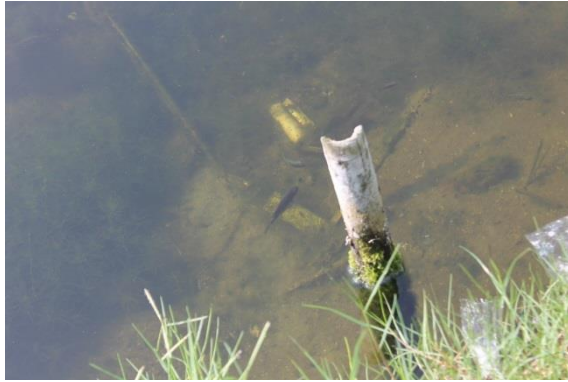
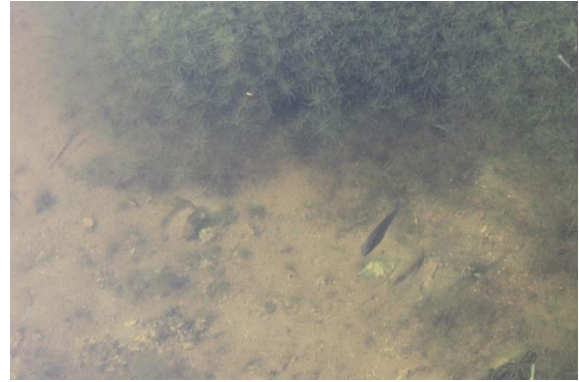
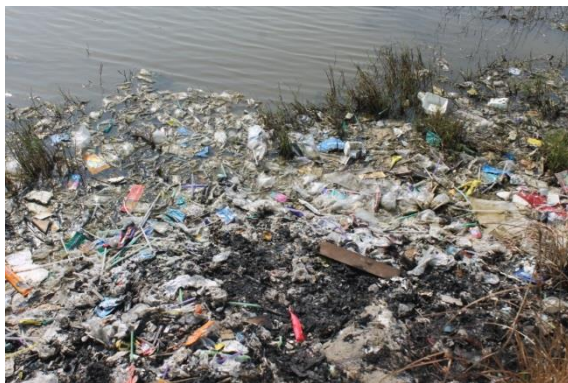
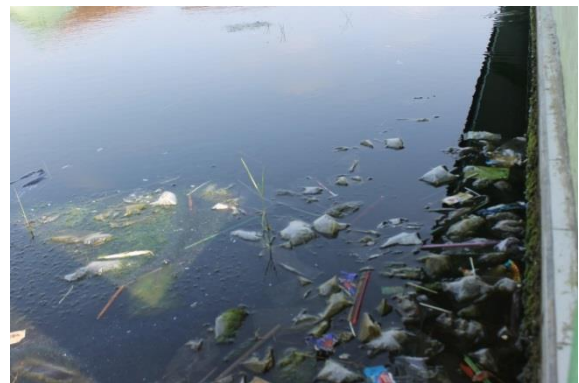
**Picture 5.** Existing conditions of observation ponds before observing at SMPN 3 Satu Atap Sayung

Fish and pond bottom are clearly visible

Fish and Hydrilla sp. seen in the waters

The pool has only been a place for garbage from the school

Trash inside the observation pond II

The research team divided the observation station into 3 (three), namely Pond I, Pond II and Pond III. The initial condition of the pond - the observation pond is quite interesting to observe. The conditions of Pond I and Pond II at the beginning of the observation are almost the same, namely the condition of the water that is very good with a good level of brightness. The bases of ponds I and II are clearly visible, even fish, snakes, shrimp and several other biota can be seen. However, the ponds have only become trash bins. In Pond II, the school had spread the seeds of shrimp and milkfish, but the results obtained were not optimal even many seeds were lost when the tide came. When the school will harvest even the results are very far from the target. However, for Pond III the condition is murky and neglected. Pond III is indeed behind the school and is the most open and very easily affected by external factors. The embankment of the pond is quite low and if the tide can enter into Pond III. Previously the area of SMPN 3 Satu Atap was dry land, and now the school has been surrounded by water.

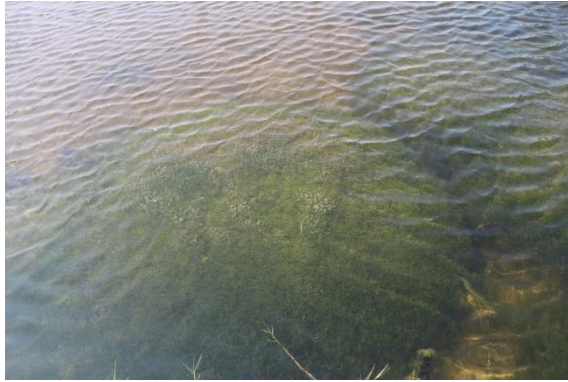
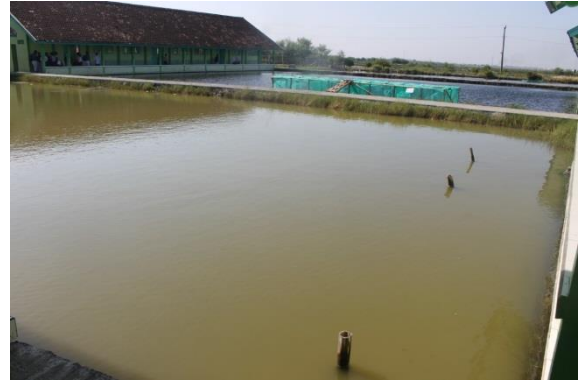
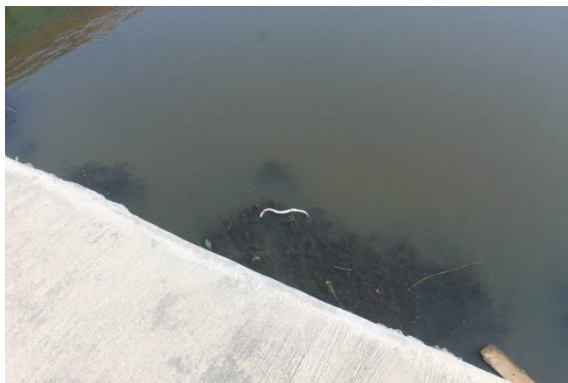
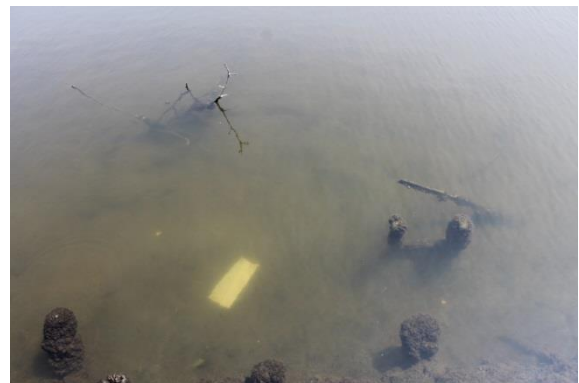
**Picture 6.** The condition of the observation pool before the ROB until after ROB.

On the 30 May observation, high tide occurred which resulted in the entire pond becoming cloudy and the conditions very different compared to previous observations. This can be seen from the observations written in Tabel 7 which are very different when observed on 30 May from observations in the previous weeks. The levels of heavy metals in a water can change according to the season, intake and flooding that affect heavy pond content in the waters and sediment. Tidal charts in the research area can be seen in Appendix 1 for April and in Appendix 2 for May.

The ROB flooding that occurred not only affected the observation pool, but this disaster affected all existing farms in the village. Fish that were in the farms were also carried away by floods and caused huge losses to the pond farmers. This is a note from the research team to observe the movement of tidal currents to mitigate disasters that will occur for the coming years. Either by controlling in aquaculture methods or coping with the selection of structures that can mitigate ROB in aquaculture activities.

Pond conditions on 11 April 2018

Pond conditions on 23 May 2018

Pond conditions on 30 May 2018

Pond conditions on 31 July 2018

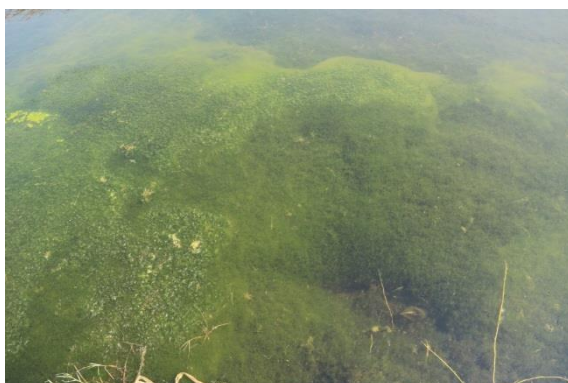
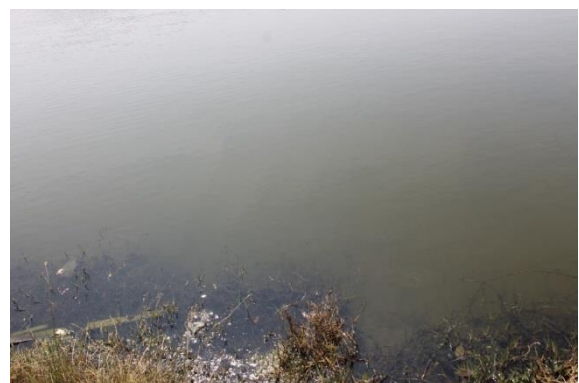
**Picture 7.** The condition of *Hydrilla* sp. before and after ROB in the observation pond.

ROB floods that occur in research locations greatly affect the ecological conditions that exist in the research location. *Hydrilla* sp., which previously flourished in Pond I and Pond II, became dead after the ROB flood. *Hydrilla* sp. did not appear at the bottom of the waters after the ROB flood. *Hydrilla* sp. can adapt to salinity, but at the time of flood the ROB of water salinity changes dramatically. In addition, several other biota are also not seen in recent observations such as snakes, fish and shrimp.

Before ROB

After ROB

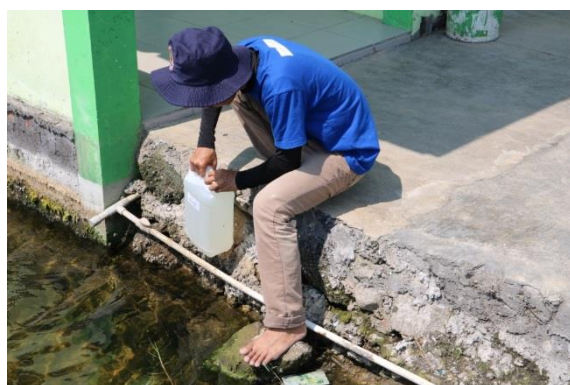
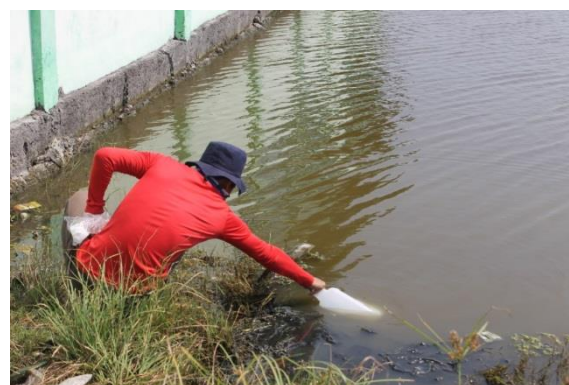
**Picture 8.** The process of water sampling at the research location for 2 times period

First water sampling is taken on 11 April 2018

Second water sampling is taken on 30 May 2018

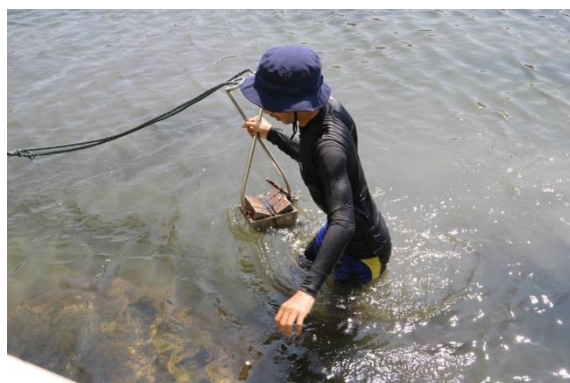
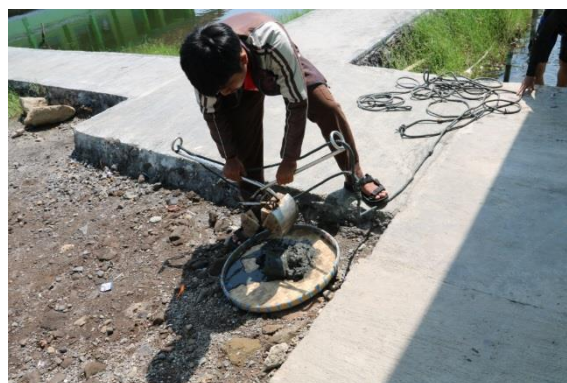
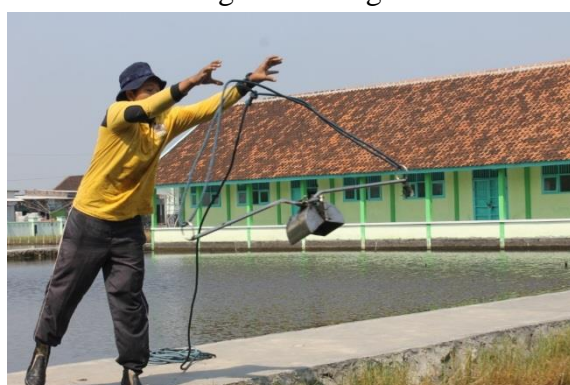
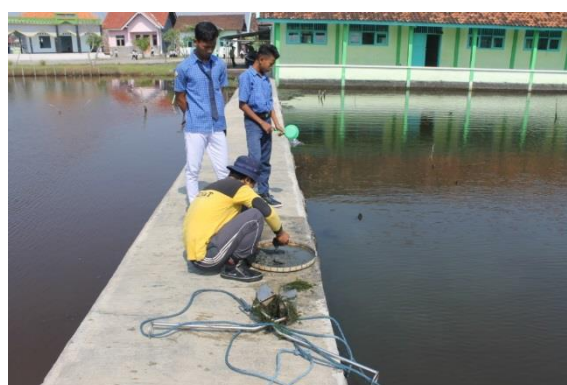
**Picture 11.** The process of sediment sampling at SMPN 3 Satu Atap, Sayung for some aspect for testing.

Taking sediment samples from each test was carried out at the same time. Sampling is done by using a sediment grab to facilitate retrieval. At the first observation the team did not get a significant obstacle, but in the second observation the sediment sampling team was constrained by *Hydrilla* sp. which died and was suspended at the bottom of the pond so that it mixed with the sediment during collection.

Taking sediment samples at the first observation using sediment grab

Taking sediment samples at the second observation

The second observation sample is quite difficult because the sediment mixes with the dead *Hydrilla* sp.

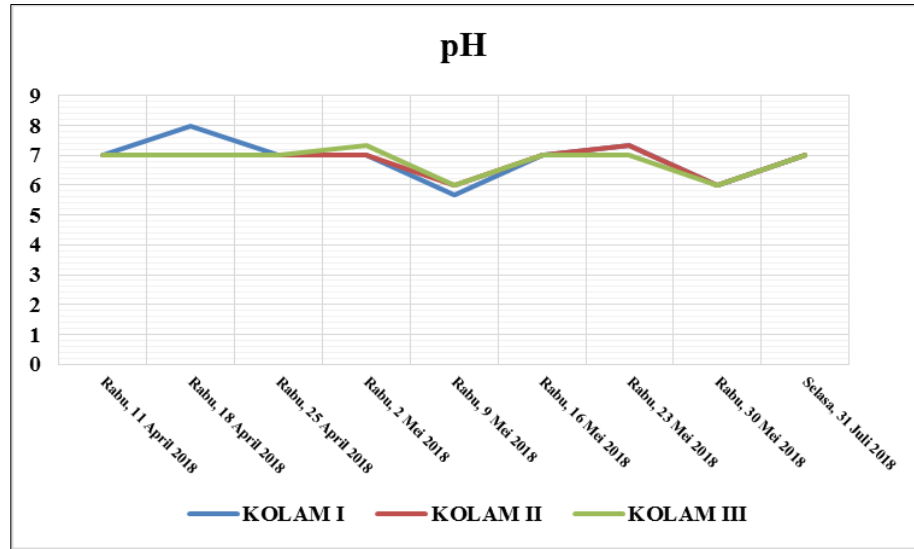
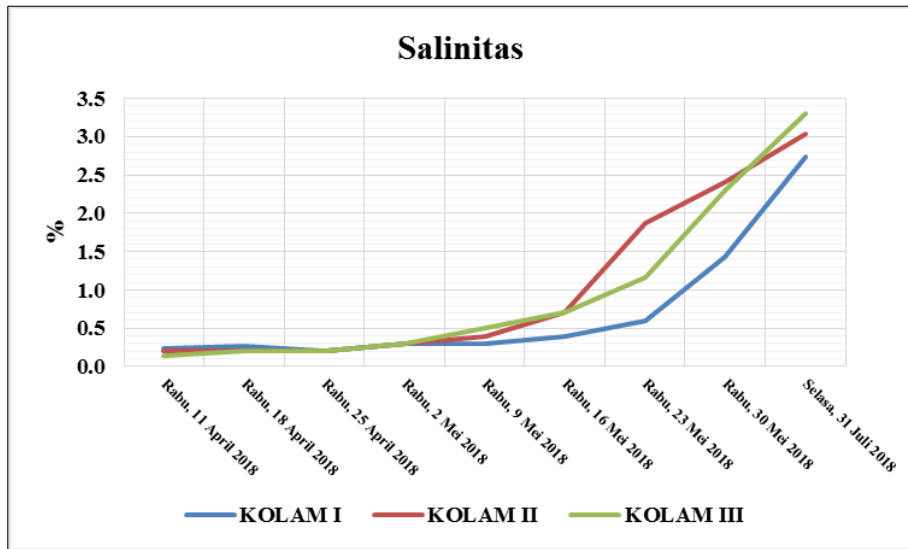
**Picture 12.** Observations of environmental parameters were carried out for 8 weeks (2 months) observations in all observation ponds.

The research team also observed periodic environmental parameters every week for 8 weeks. This is done to find out the in situ conditions that exist in the research location. Observations include pH, temperature, salinity, DO and brightness. These environmental parameters are one of the important aspects in the success of fish farming. Matters to be considered to increase fish production are conducting water quality management, feed management, and optimal stocking density (Karlyssa *et al.*, 2014).

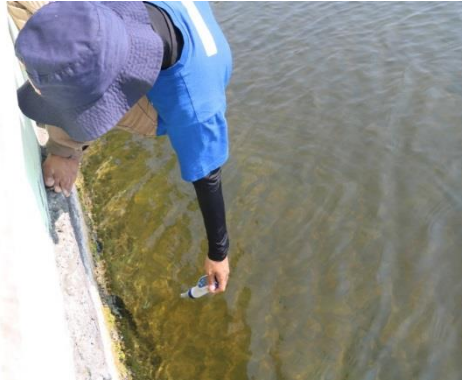
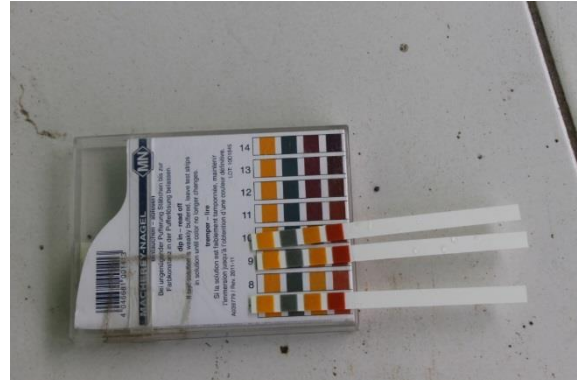
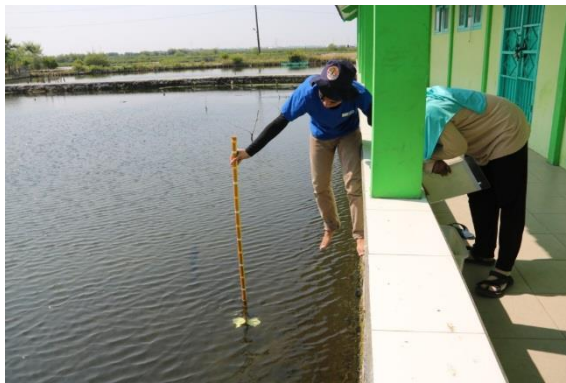
**Picture 13.** Weekly monitoring for water quality control at each observation pond at SMPN 3 Satu Atap Sayung

Measurement of temperature and salinity of the observation pond

pH measurement in each observation pond

Measurement of water brightness

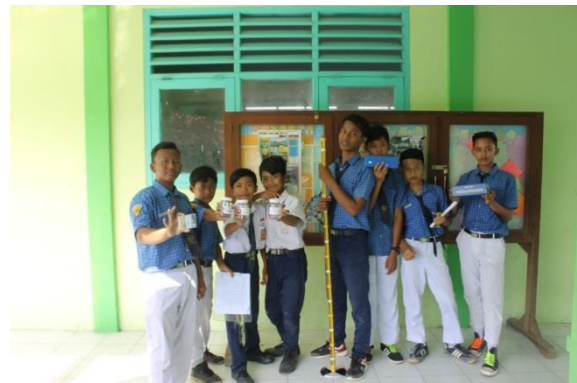
Student involvement in monitoring

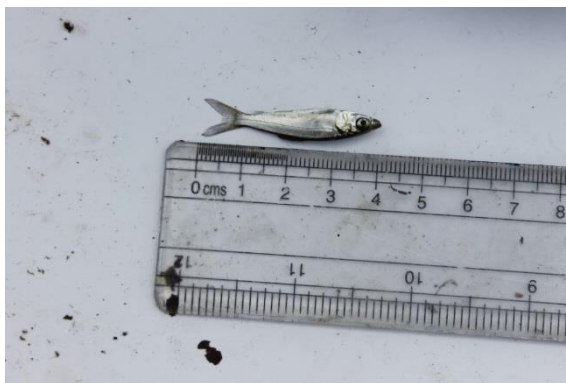
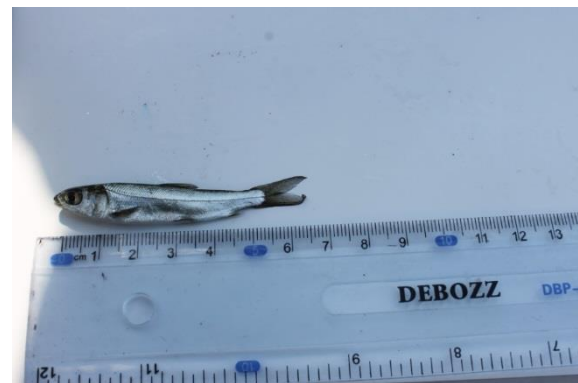
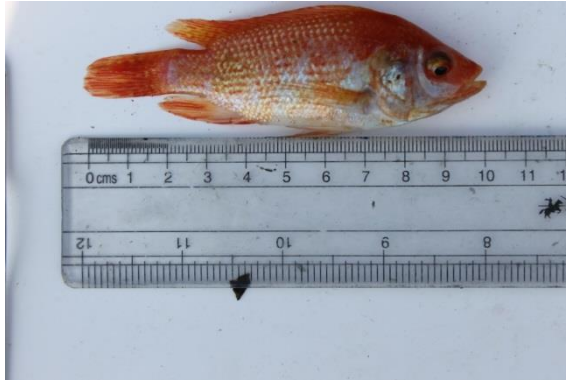
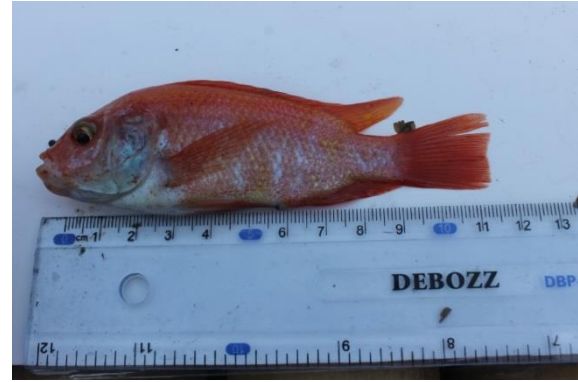
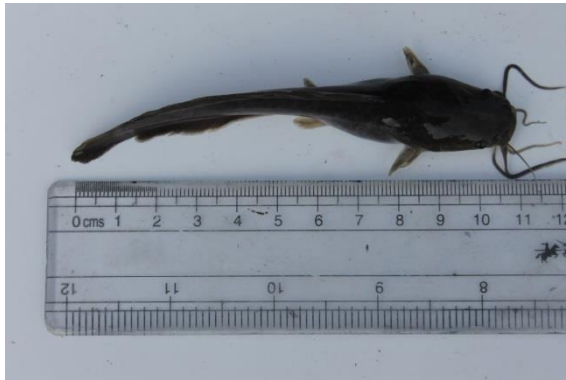
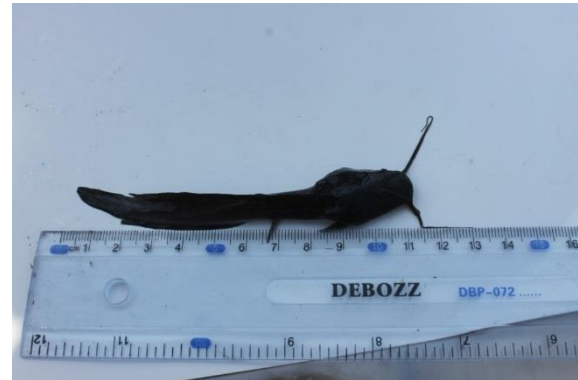
**Picture 14.** Conditions of trial fish in the experimental pond at SMPN 3 Satu Atap Sayung.

From Picture 14, it is seen the development of fish from the second week of observation until the seventh week before the occurrence of the ROB flood. Fish in the experimental pond are able to withstand the environmental conditions of the weeks. However, it appears that Catfish do not show significant development. This is indicated because of the lack of proper feed used, but for testing the salinity of Catfish, it can compete before the ROB occurs. While for the Tilapia the development is a little slow but with the existing salinity able to survive. For the final results of the observations (July 31, 2018) it was found that Tilapia was able to survive as many as 17 birds (out of 75), Milkfish 50 - 60 (from 100), Catfish entirely dead (out of 75) and seaweed as much as 244, 6 gr (of 15 kg). Tilapia can be an option in the aquaculture activity at SMPN 3 Satu Atap for the future.

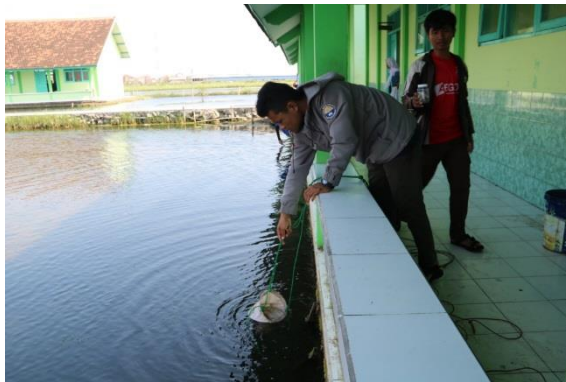
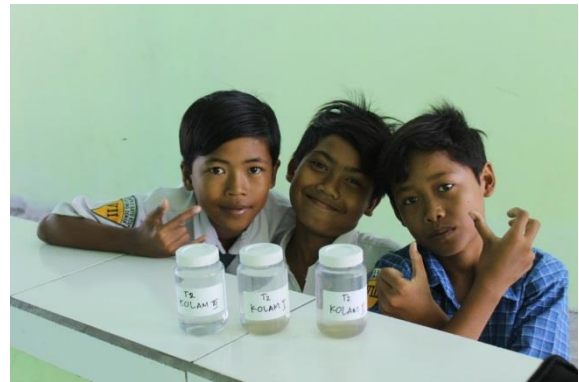
Plankton net withdrawal in the sampling process

Plankton samples after being put into a 4% formalin sample container

Plankton sampling is carried out on the same day and hour. In this study, the team took samples every 8 o'clock in the morning. Taking plankton samples is recommended for as early as possible. Observations are carried out every 2 weeks for 2 months. Samples that have been taken with planktonet will be inserted into the sample bottle which has been filled with 4% formalin. The comparison of plankton samples with preservatives is 1: 5. The bottle of sample used has a volume of  $\pm 200$  ml. In identifying plankton, the research

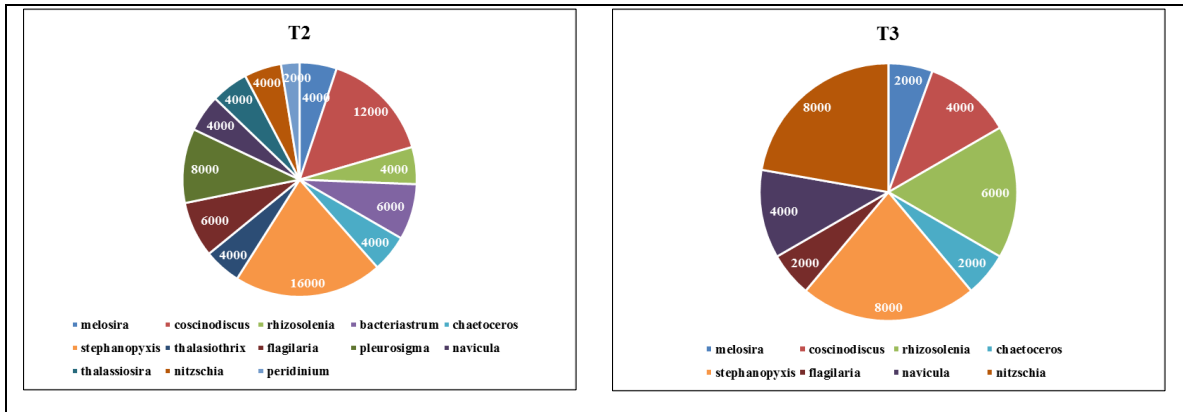
**Picture 17.** Phytoplankton abundance (cell / L) diagram in Pond II in 4 observations at SMPN 3 Satu Atap, Sayung

For the results of observations in Pond II for 4 times the sampling in the field, the same results are obtained as in Pond I that the genus *stephanopyxis* is still the genus that has the highest abundance of each sampling in the field.
